# Mobile Intel® Celeron® Processor on .13 Micron Process in Micro-FCPGA Package

Specification Update

*April 2004*

Document Number: 251309-019

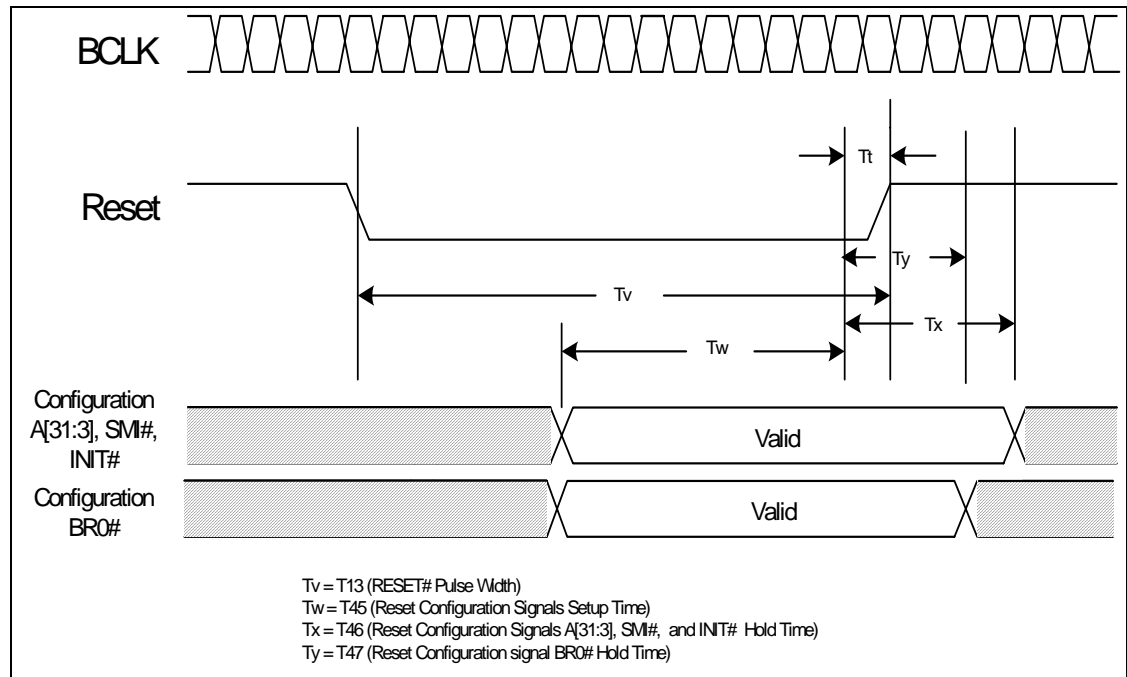
**Figure 12. System Bus Reset and Configuration Timings**

The BR0# maximum hold time has changed to 2 BCLKs. This change will be shown in the “System Bus AC Specifications (Reset Conditions)” table and “System Bus Reset and Configuration Timings” figure of the *Mobile Intel® Celeron® Processor on .13 Micron Process in Micro-FCPGA Package Datasheet*. This change will be incorporated in the next revision of the datasheet.
